Inspection Report Minerals Regulatory Program

Report Date November 4, 2005

Mine Name: Deremo-Peterson Operator Name: Umetco Minerals Permit number: M/037/025 Inspection Date: August 18,

M/037/025, Deremo/Peterson Mine, Umetco Minerals

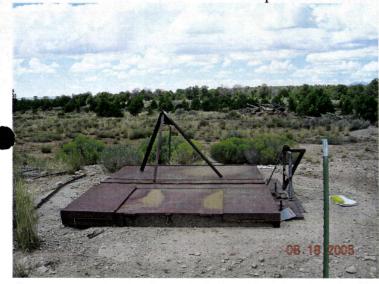
The shaft that was to be developed as a water well is shown in Photo 1. The well has not yet been developed, but the shaft is covered with hinged steel plates. I was not able to lift these plates and open the shaft, but it did not appear the plates had been welded shut.

Photo 1. Seven-foot vent hole to be developed as a water well. This is the northernmost vent hole.

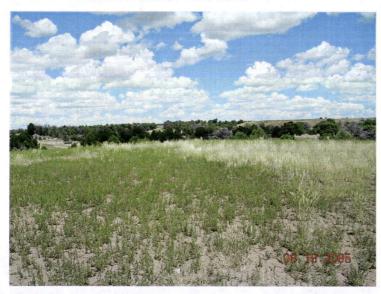
The waste pile has a fair amount more grass than it did last spring, and the ore stockpile area also has a little more vegetation.

There is not yet enough cover on the waste pile or in the ore stockpile area for it to be released. However, the operator could make a strong case that everything practical has been done to revegetate these areas.

Photo 2. The top of the waste pile.

I recommend waiting until spring to reevaluate the vegetation on the waste pile and ore stockpile area and see if it then meets traditional release standards. If not, the operator could make the argument that everything practical has been done in these areas.

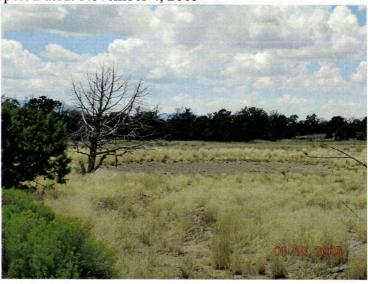
The pond is very shallow (perhaps two feet deep), but it does not appear the operator attempted to reclaim it. The area around the pond was well vegetated, primarily with foxtail barley, but the bottom of the pond had no vegetation, not even weeds.

The undisturbed area around the pond has about 29 percent cover, and cover in the pond area itself, including the embankment, the bottom of the pond, and surrounding disturbed areas, is about 24 percent.

It does not appear the pond was regraded, but it is so shallow that it presents no danger. There is enough vegetation around the perimeter of the pond that, even with no vegetation in the bottom, the average cover meets release criteria.

Photo 3. The sediment pond. Most of the vegetation is foxtail barley.

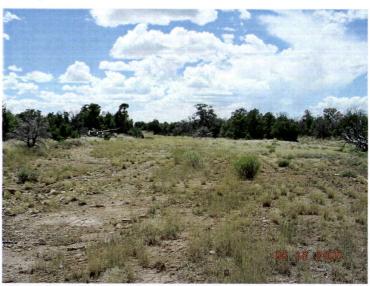
The Snyder #4 hole is the southernmost of the vent holes. The road leading to this area (Photo 4) and the area of the vent hole itself (Photo 5) are well vegetated.

Photo 4. The road to Snyder Vent Hole #4.

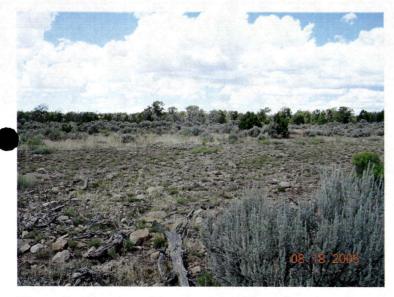
Photo 5. The site of Snyder Vent Hole #4.

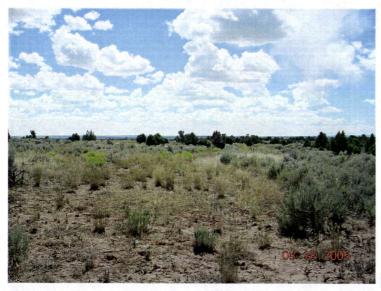
I was not able to find the exact location of the 5-foot diameter hole which is the westernmost of the vent holes, but Photos 6 and 7 show the road leading to this hole and the general area where the hole is shown on the map.

Photo 6. The road leading to a 5-foot diameter vent hole. This is the westernmost of all the holes.

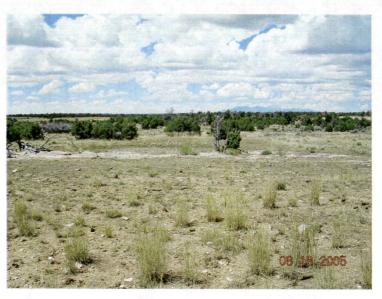
Photo 7. The area f the westernmost vent hole.

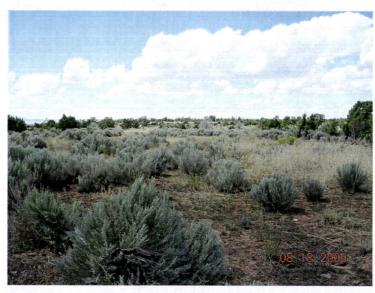
The map from the plan shows a hole right on the Colorado border, and while I found where this hole should have been (Photo 8), I saw no clear evidence of disturbance.

Photo 8. The general area of a 5-foot diameter vent hole right next to the Colorado border.
